Republic of the Philippines DEPARTMENT OF SCIENCE AND TECHNOLOGY Philippine Atmospheric, Geophysical and Astronomical Services Administration (PAGASA)

Report on: Pagsanjan River Flow Assessment (results through river cross-sectioning activities) by PRBFFWC, NCR-PRSD, PAGASA

The River Cross-sections: Station 1

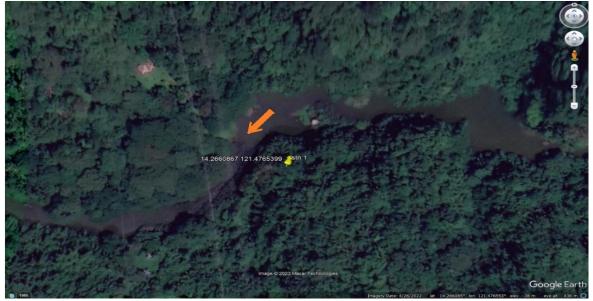
Top pic (1): A google earth map representation of point for station 1 river section; Far left pic (2): river cross-section measurements were done through wading across the river channel; Left pic (3): the location / position of the temporary benchmark (TBM) was the ground elevation of a makeshift basketball half court located on the RB, d/s side of the measured x-sect; Below pic (4): a general view of the Pagsanjan River section as seen from the RB side of the river.

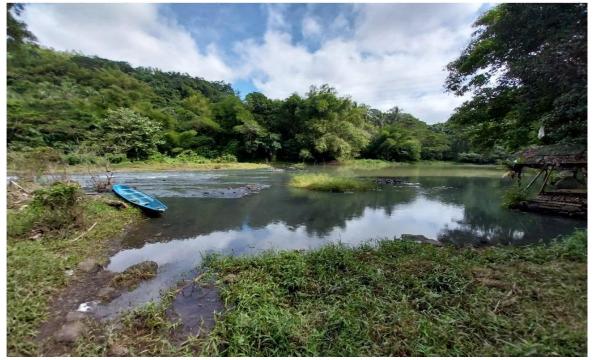
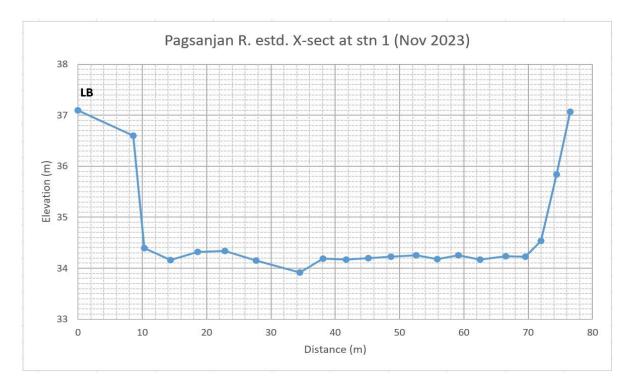
Top Figure (1): Above shows the estimated river x-section of Pagsanjan River at station 1 with the elevation of TBM reckoned from Google earth map.

Left Figure (2): The Elevation vs. Area (H-A or WL-A curve) at the said section showing a general straight line relationship.

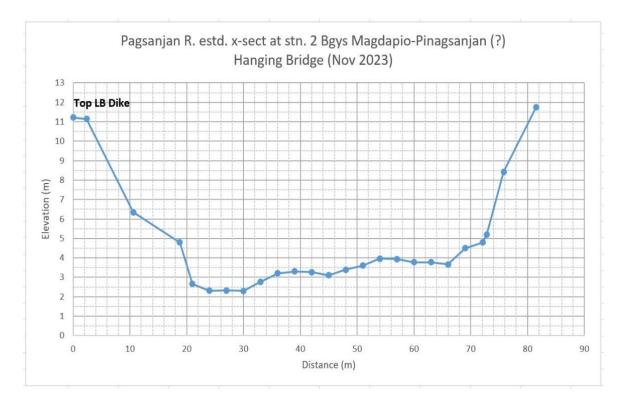
Top Figure (3): The surveyed cross-section of Pagsanjan River at station 2. The crosssection was taken at the u/s side of a hanging bridge at that river section.

Left Figure (4): The graph representing the H-A curve for the said station.

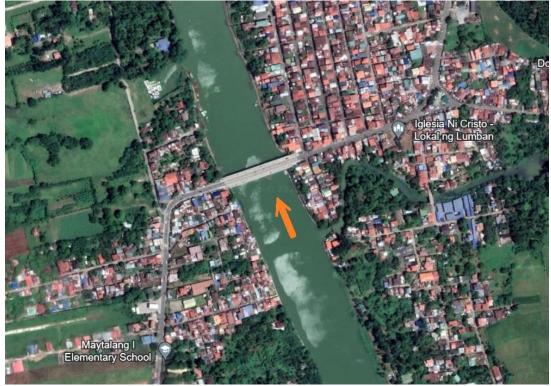
Top pic (10) Google earth view of the Pagsanjan River channel at station 3 (Lumban Bridge) with arrow pointing to the direction of river flow.

Above left pic (11) Shows the view of the LB side of the Pagsanjan river as seen at the downstream side of the Lumban Bridge.

Above middle pic (12) A general view of the RB portion of the station 3 channel as seen from the downstream side of the Lumban Bridge.

Above right pic (13) The staff gage at the Lumban Bridge situated at d/s side of one of the bridge's pier and was mentioned to be referred to MSL; the staff gage was the basis for elevation for the measured x-sect of the said station.

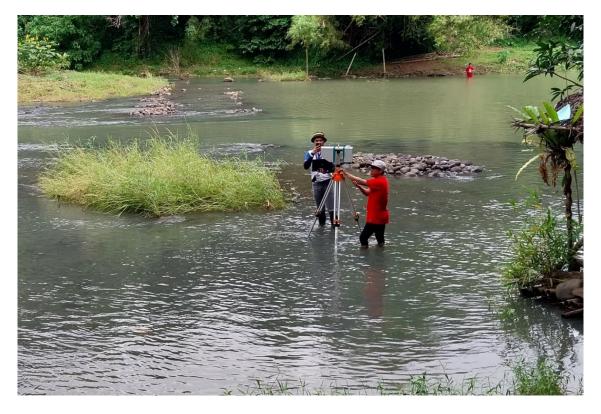
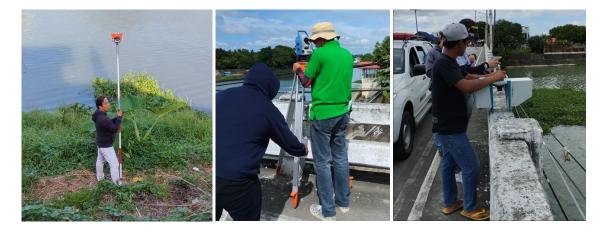
Some pictures taken during the measurement activities (Nov 21-23, 2023)

Above pic (14) Taking river surface velocity measurements by wading along the shallow portions of Pagsanjan River in station 1.

Left pic (15) River surface velocity measurements being carried-out atop the hanging bridge in station 2.

Below left pic (16) Taking bank elevations at the LB in station 2.

Middle pic (17) Setting-up the total station for determination of x-sect elevations at station 3. Below right pic (18) River surface velocity measurements being carried-out atop the Lumban Bridge (station 3).
